TROUBLESHOOT PACKING MALDISTRIBUTION UPSET PART 2: BOILING AND FLASHING IN PACKED TOWER DISTRIBUTORS

Henry Z. Kister, Walter J. Stupin and Jelle Ernst Oude Lenferink
Fluor Corp., 3 Polaris Way, Aliso Viejo, California 92698, USA

This paper describes troubleshooting the poor performance of a packed distillation tower and a condition called “upset” in which rapid heating up occurred near the top of the tower. The investigation combined surface temperature surveys, grid, distributor and CAT gamma scans, simulation, and a hydraulic analysis. Part 1 describes the field tests; Part 2 the simulation, hydraulic analysis and fix.

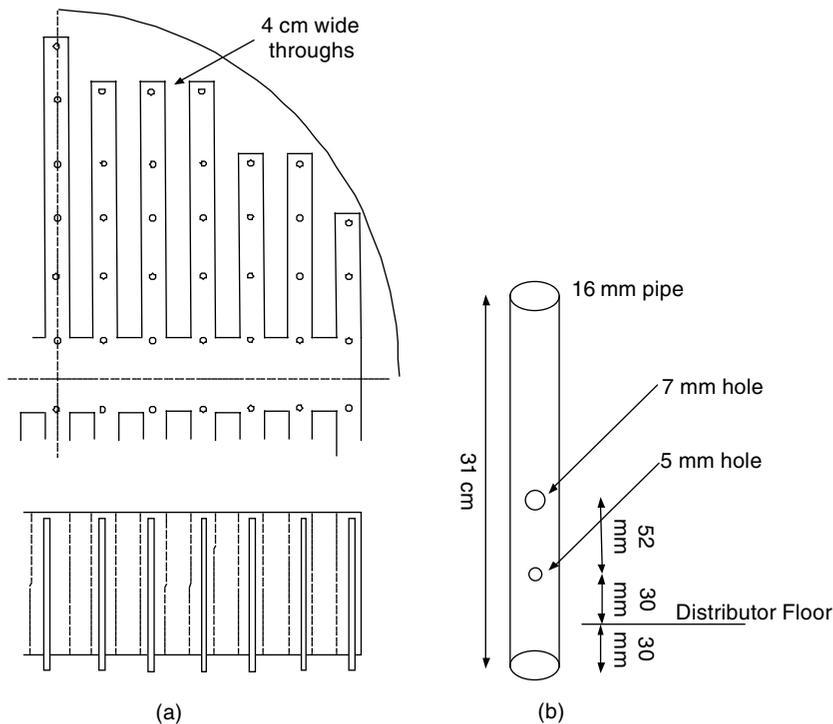
Figure 1. Feed distributor (a) plan and elevations (b) flow tube details

Both feed and reflux distributors were of a similar design. Figure 1 specifically shows the feed distributor, but the diagram is used to depict both.

The feed distributor consisted of 4 cm wide troughs with 16 mm tubes inside. Each tube was 31 cm total length, with 3 cm protruding below the distributor floor. Each tube had a

5 mm hole at 3 cm above the floor, and a 7 mm hole at 8 cm above the floor. The feed entered the distributor 150 mm south-east of the center of the parting box (Figure 2) via a downward-elled 2-inch pipe which terminated 40 mm above the floor of the parting box. Prior to installation, the distributor was water-tested at the vendor shop with good results.

Listening to the column near the feed point, one could clearly hear banging and popping sounds, indicating that the feed was flashing. A flash calculation confirmed that 2.8% of the feed by weight, or 99.4 by volume, was vapor. The feed distributor was a liquid distributor that is inadequate for any significant vapor in the feed. Gamma scans show entrainment from the distributor, most likely caused by the high flashing feed velocities spraying liquid all around.

Small holes of 5 mm are prone to plugging. There were past episodes of plugging, but the tests shed no light on this possibility. The calculated liquid levels for both normal and upset conditions were 8.5 cm above the floor, compared to 7 to 9 cm as measured by the gamma scans. Had all bottom holes been plugged, the calculated liquid level would have risen to 11 cm. So within the accuracy of the level measurement, the tests were inconclusive on distributor plugging. Subsequent inspection at the next turnaround showed no plugging.

In conclusion, flashing in the feed distributor was identified as the root cause of the bottom bed maldistribution.

Like the feed distributor, the reflux distributor (Figure 1) consisted of 3 cm wide troughs with 12 mm tubes inside. Each tube was 31 cm total length, with 3 cm protruding below the distributor floor. Each tube had a 3 mm hole at 3 cm above the floor, and a 5 mm hole at 8 cm above the floor. Reflux entered the distributor via a downward-elled 2-inch pipe that terminated 40 mm above the floor of the parting box right at the tower center. Prior to installation, this distributor too was water-tested at the vendor shop with good results. In a recent turnaround, the distributor was water-tested in situ, and qualitatively observed to distribute the water well.

The remaining reflux liquid proceeded to the troughs. The reflux entered the distributor at the center of the tower, at about 87 °C, while the tower overhead vapor was at about 176 °C (normal condition). The narrow troughs and the multitude of drip tubes provided lots of heat transfer area, and the delta T (90 °C) was tremendous. The volatile component boiled rigorously inside the troughs, but especially inside the drip tubes. The heat curve of the reflux was such that much of the boiling would take place at temperatures very close to the bubble point, so the boiling is likely to have been extensive. There was ample residence time in the distributor and parting box (we estimate an average of about a minute), giving plenty of opportunity for heating and boiling to take place. Even more so, there was intense boiling in the 12 mm tubes through which the distributor liquid descended onto the packing. These tubes had a large area to volume ratio. With condensation on one side of the tubes and boiling on the other, there was a good heat transfer coefficient. These tubes became an efficient heat exchanger that boiled the descending liquid. Our heat transfer calculations leave little doubt that extensive vaporization took place in these tubes.

This boiling was most intense in the regions rich in the volatile component, and short of residence time, i.e., near the center of the tower. Due to the high concentration of the volatile component, it is likely that the tubes became "falling-film reboiler" tubes, so that little liquid descended in this region. As one moved away from the center, some of the volatile component was depleted from the troughs, leaving the heavy boiler, which remained in the liquid. Boiling in the peripheral regions was therefore diminished, and the liquid descended onto the packing as intended. This gave the observed pattern of preferential vapor flow in the center and uneven peripheral liquid flow around the sides.

- **Redesign the reflux inlet to accommodate flashing, to minimize boiling in the distributor, and to eliminate boiling in the distributor tubes.** A flash box was added at the reflux entry to adequately separate any flashed vapor from the reflux before feeding the liquid to the reflux distributor. The previous distributor with the drip tubes was replaced by a different type of distributor without drip tubes. This new distributor eliminated the tubes in which much of the intense boiling took place. A thermal shield was built around the distributor walls and bottom to minimize boiling. Also, this distributor had larger holes, giving a much better plugging resistance.

- **Redesign the flashing feed inlet.** A flash box was added at the feed entry to adequately separate the flash vapor from the feed, and to adequately mix the feed liquid with the liquid collected from the bed above, before feeding the liquid to the feed distributor. The previous distributor with the drip tubes was replaced by a different type of distributor without drip tubes.
