PLATE DAMAGE AS A RESULT OF DELAYED BOILING

K. Hallenberger , M. Vetter

Bayer AG, Leverkusen

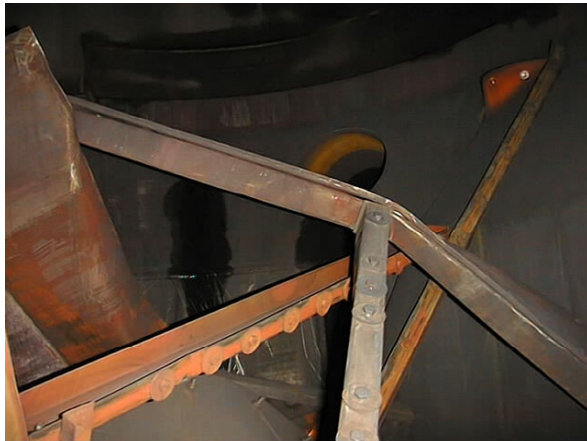
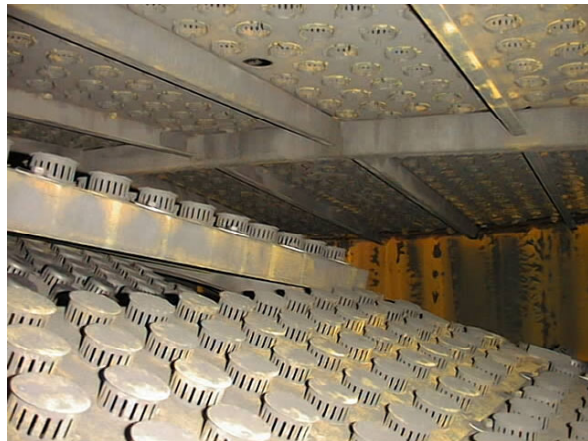
The two photographs shown below demonstrate very impressively, the extent of the damage. It can be seen quite clearly that the trays buckled or were split apart in an upwards direction, so the force being exerted must have come from below the trays. 20 to 30 trays were damaged during each of the three incidents. The repair costs were about 250 T€ each time. You can get an idea of the destructive forces involved when you realise that the tray sheet metal was designed for a mechanical load of 70 mbar pressure difference and the supporting reinforcement parts were actually designed for 200 mbar pressure difference. The noise made during these events was not noticed.

Damage to distillation trays is not unusual. Damage is generally the result of poor maintenance, structural defects or a lack of the required measuring devices, which then results in normal loads being exceeded. However, damage occurred three times within 1½ years to column trays in a tray column, after the column had been shut down. Shutting down the column is the final safety precaution taken when critical conditions occur in any column. This is done primarily to protect the environment from the emission of hazardous substances and secondly to return the apparatus to a safe condition.

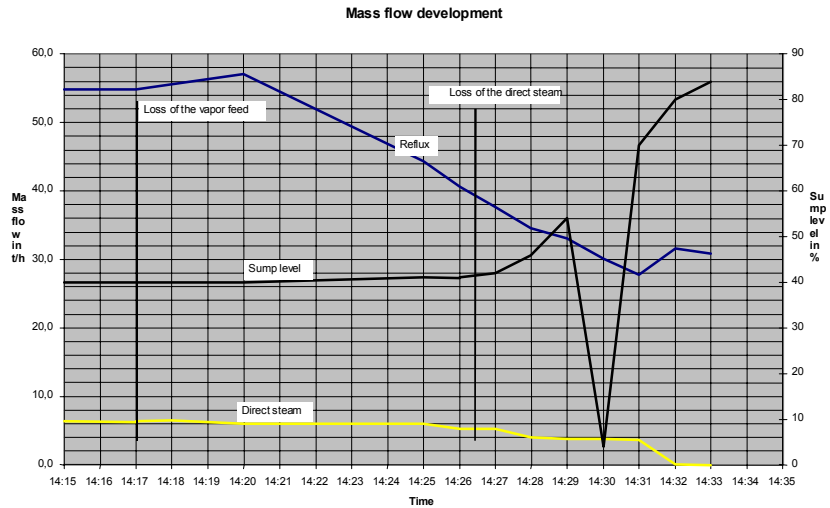
Change in pressure as seen from the data archiving programme 'IMPASS'

The three monitoring points: head pressure, absolute pressure at the feed point, pressure at the sump, as well as the level of liquid at the sump where the level is maintained using a pump are shown.

At about 14:17 the column was subject to an emergency shut-down due to a power failure. At this point the direct steam is taken over manually using the actual value. The head pressure in the column can be kept constant by means of regulation of the adjustable level. Due to the lack of product vapour, the pressure difference in the rectifying section decreases and the trays drain. The pressure at the feed point drops due to the reduced loss in pressure. The total pressure at the sump of the column also drops. The pressure drop in the stripping section however increased due to the liquid drained from the upper trays.

The processing data, which were recorded using the archiving system 'IMPASS', have only a limited resolution with a recording frequency of one minute.

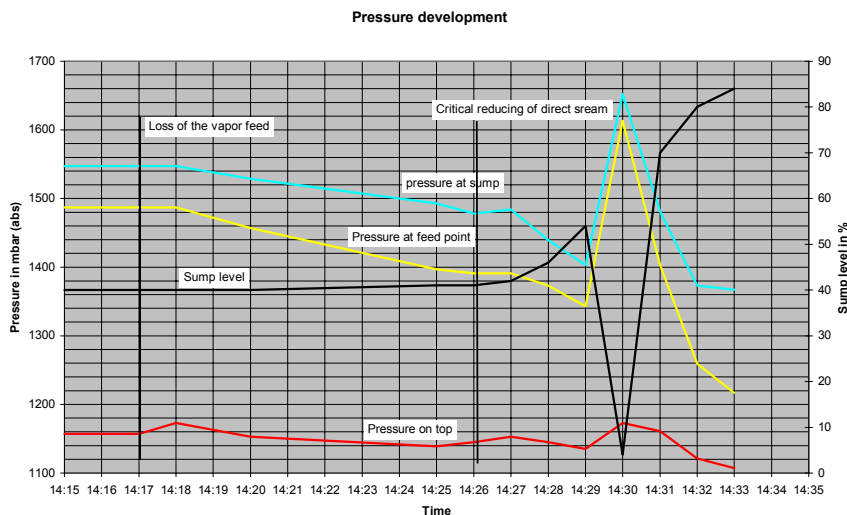
After 14:25, the direct steam at the sump of the column is reduced stepwise. Due to the increased amounts of liquid on the trays in the stripping section, these trays also start to drain, which is indicated by a rise in the bottoms level. The pressure drop at

the feed point and at the sump of the column takes place more rapidly. At about 14:27 the bottoms level falls spontaneously from 54 to 5 %. Simultaneously the pressure gauges at the sump and at the feed point increased rapidly by 250 mbar. At the column head, the pressure increased by only 38 mbar. This shows that an extreme pressure difference over the column trays was generated.

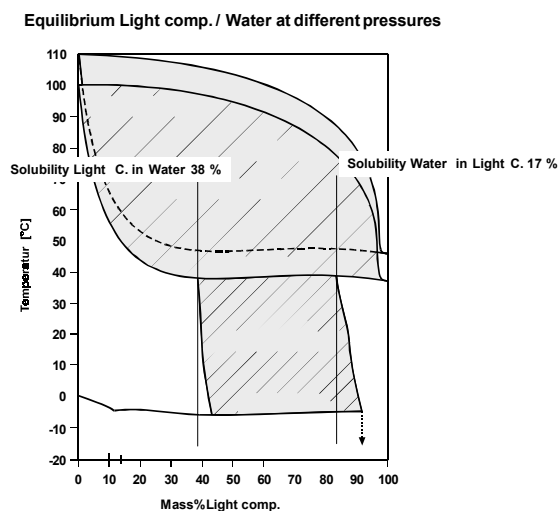
The phase equilibrium diagram for the light component/water system shows that the system is only partly mutually soluble and that with no azeotrope is formed. Thus there are reasons for supposing that the partial solubility of the system is the cause of the damage to the trays. The density difference between the two liquid phases is about 160 kg/m^3 , with water being the denser phase.

Thus, there was reason to believe that the light component draining downwards formed a second phase on the aqueous sump product. The liquid phases have a boiling temperature difference of about $40 \text{ }^\circ\text{C}$. The sump of the column, about 5 m^3 of water, contains enough energy potential to vaporise part of the organic liquid and produce amounts of vapour which could lead to the damage observed.

The chlorinated component, present at only 3 % in the feedstock, is virtually insoluble in water and forms a heteroazeotrope. The phase equilibrium with the light component is ideal. As is normal with chlorinated products, the density of the liquid is greater than that of water.

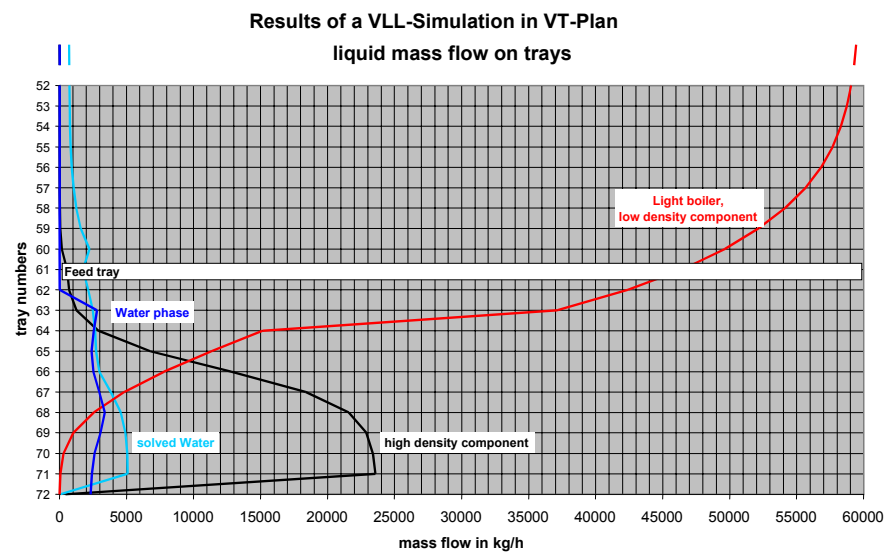
3-phase flash calculation

To determine the profile under normal operating conditions, the column was calculated using VT-Plan, an internal Bayer simulation programme. The equilibrium was described using the NRTL approach and the liquid was assumed to be in 2 phases. The results of the calculation are shown on the following slide. The curves show the component streams over the last 10 rectifying trays and all the stripping section trays.

It can be seen quite clearly that an aqueous phase is formed only in the stripper section. The aqueous phase is between 2.3 and about 3 t/h. The proportion of organics in the aqueous phase is less than 40 kg/h and can be ignored here. The column separates the organic phase into 2 definite zones:

- The 4-5 trays directly above the sump show a pronounced intermediate boiler bulge which mainly contains the chlorinated component. The maximum mass flow of the chlorinated component is 23 t/h.
- Above this zone, the concentration of light component increases steadily until it reaches 60 t/h in the non-aqueous region. The amount of water dissolved in the organic phase, at a maximum of 5 t/h, is greater than that in the pure aqueous phase.

The composition on the stripper trays was estimated using this calculation.

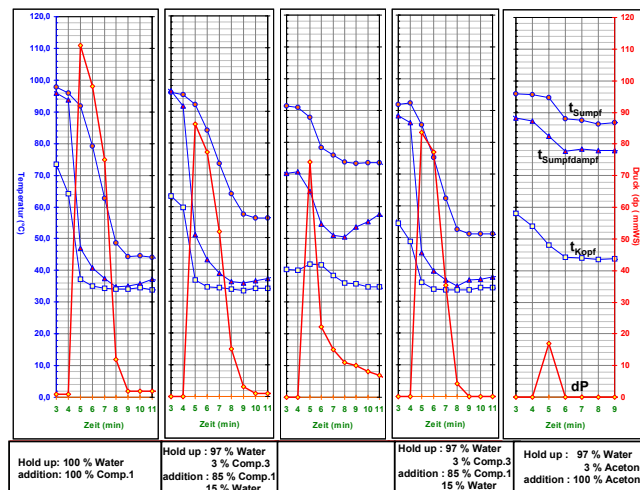
Laboratory results

The slide shows some examples of trial results.

The first curve shows the results when pure water is introduced to the column and pure light component is applied to the column. The sudden pressure difference and the temperature drop in the column are the most pronounced of all the trials. Variations in the product added, such as for example a light component with maximum water-solubility or a representative mixture, lead to lower pressure differences and smaller temperature drops at the sump of the column. Curves 2 and 4 show that the results are very reproducible.

The same trial with water and acetone, which is completely miscible with water, shows for similar boiling point differences only a small increase in pressure difference and only a small temperature change at the sump of the column.

The energy differences are partly compensated for by good mixing in a soluble system.
